# Intelligence Memorandum

The Israeli Attack on the USS Liberty

CENTRAL INTELLIGENCE AGENCY Directorate of Intelligence 13 June 1967

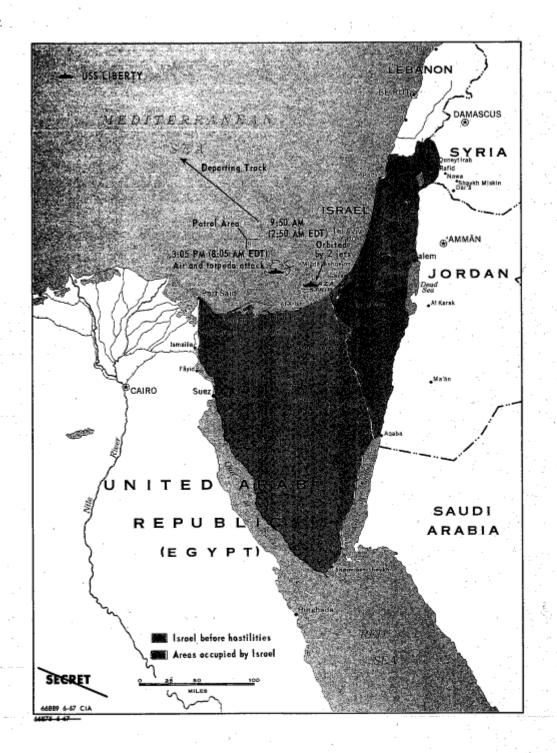
8. The ship suffered heavy material and personnel casualties. A hole estimated to be 39 feet wide at the bottom and 24 feet wide at the top near the waterline was opened by a torpedo. The ship is flooded below the second deck between frames 52 and 78 (36-inch frame spacing) The crew carried out emergency destruction of classified communications and radar equipment, but the ship's engineering plant is intact. Several flash fires and cannon holes throughout the superstructure caused some minor damage, and the ship's motor whale boat and

virtually all of its life rafts were lost. Personnel casualties include 10 killed, 90 wounded, and 22 missing, most of whom were probably trapped in the flooded compartments. The wounded and the dead have been removed from the ship and some additional crew members put aboard The ship is expected to arrive in Malta on 14 June for dry docking and hull repairs. Security precautions are being taken to protect the classified intercept equipment in the flooded spaces. The US Navy has convened a board of inquiry to look into the incident.
